LAND RECLAMATION AND ENVIRONMENTAL COMPLIANCE OF SURFACE  
COAL MINES - INTERNSHIP WITH KNIGHT HAWK COAL, LLC

SPECIAL PROJECT REPORT

Submitted in partial fulfillment of the requirements  
for the degree of Master of Science in Natural Resources and Environmental Sciences  
in the Graduate College of the  
University of Illinois at Urbana-Champaign, 2015

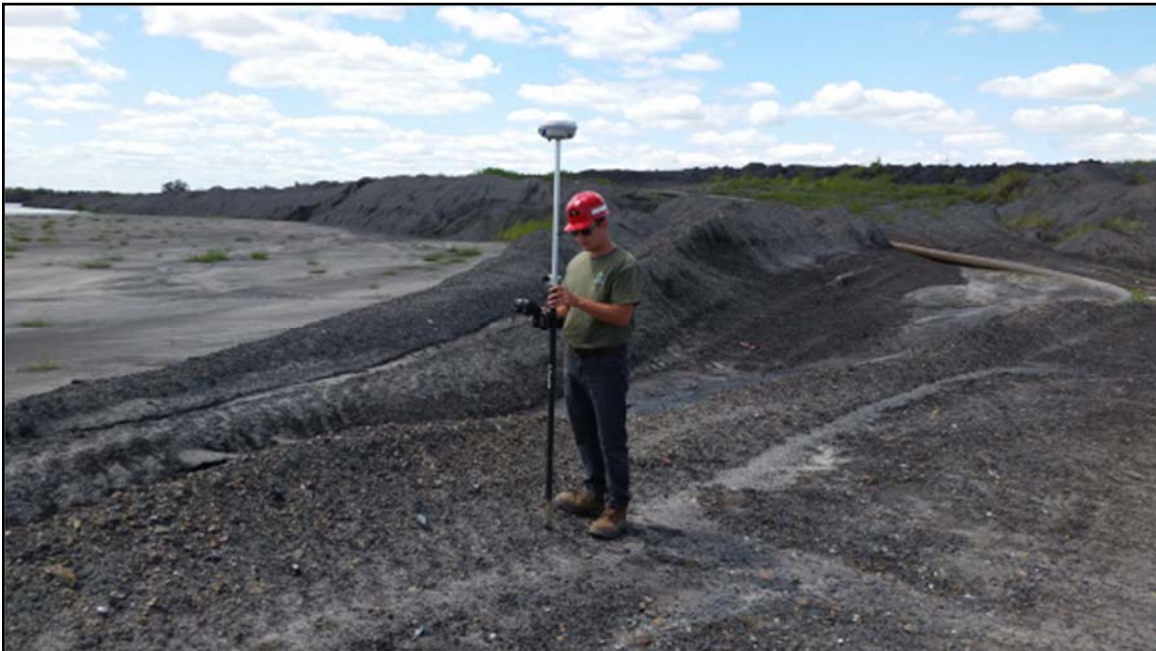
**Figure 4: Intern using a Trimble R6 GPS to take elevation points of Old Ed Carbon Recovery Mine.**

The intern collected four hundred fifty elevation points using a Trimble R6 GNSS Model 2 rover with a staking rod and a Trimble TSC3 receiver. The advantage of this system is that it does not require a base station, as it is built into the rover, however internet connectivity is required and a cell phone with hot spot capabilities must be used during data collection. Although the Trimble R6 can be stationed on an ATV or vehicle, the rough terrain of the landscape required data to be collected on foot. The location of the data points were collected based upon visual observation of changes in elevations, and additional points were collected in areas of specific interest (e.g., slurry ponds, hillsides, ridges, etc.).

The more data points collected in a given area allow for the creation of more accurate and detailed terrain maps. Once the intern collected all data points using GPS hardware in the field, the elevations of all points were uploaded into AutoDesk Natural Resources Mining & Metals package software. Under the guidance of a professional engineer, the data point elevations were then extrapolated to create a map of contours that demonstrate the landscape terrain.

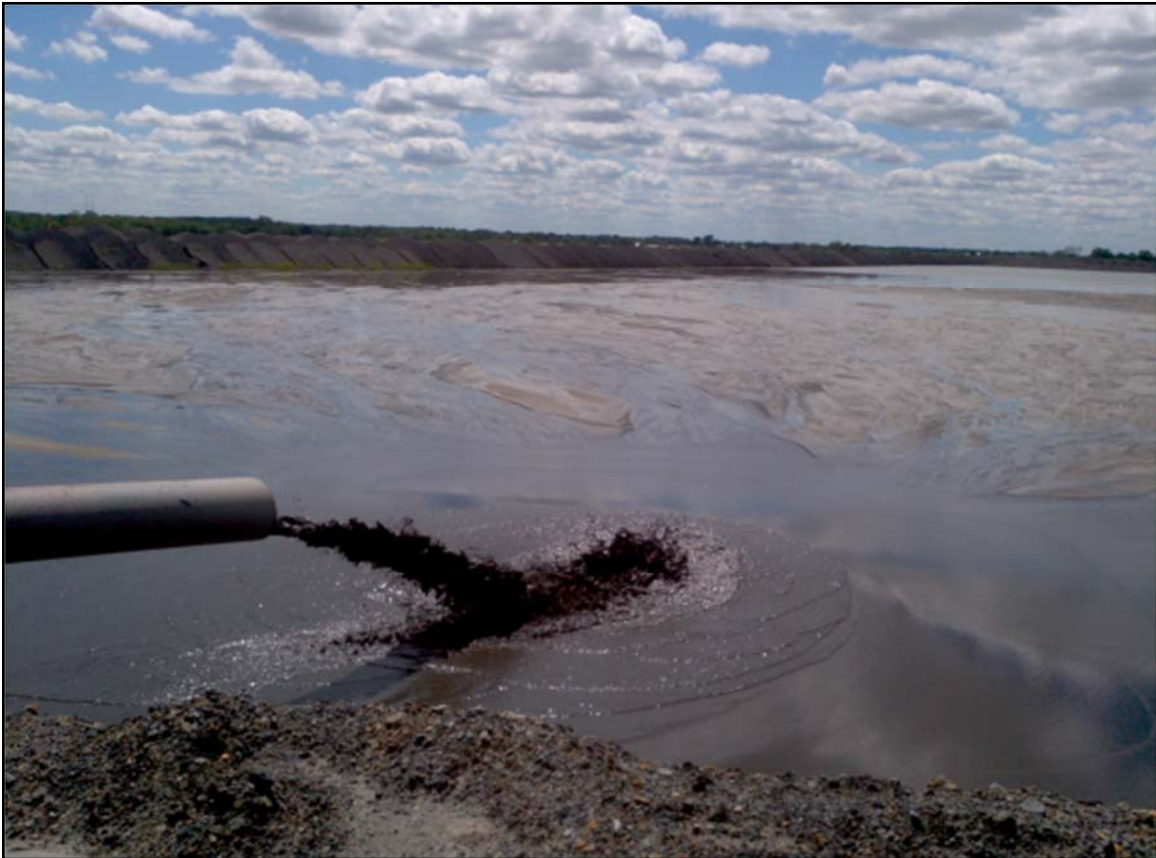
**Figure 5: Slurry is being pumped into a slurry pond at Red Hawk Mine.**

The intern collected data at Red Hawk Mine using the same hardware and software mentioned. Data points of the bathymetry (underwater relief) and elevation of a slurry pond were collected to determine the volume of water held in the slurry pond. The intern used a depth finder and portable boat to collect 150 points along the shoreline and cross sections of the lake. The volume of water in slurry ponds change as slurry settles to

the bottom of the pond and water is pumped or decanted into other water features. The volume of water must be measured periodically to assess how much additional slurry can fill the pond.

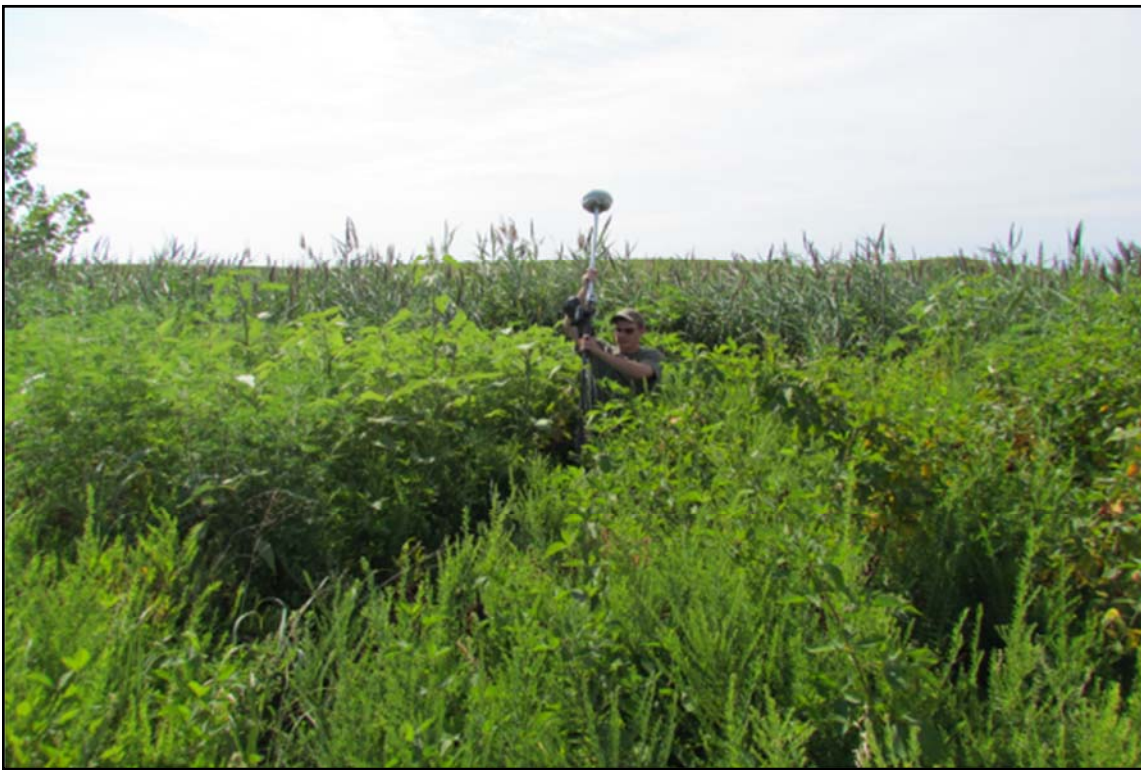
**Figure 6: Intern using a Trimble R6 GNSS GPS to map areas of *Phragmites australis*.**

The intern collected on-site data on vegetation type in the Walkers Creek floodplain. The intern walked perimeters of *Phragmites australis* (Common Reed) patches using a Trimble R6 GNSS Model 2 rover with a staking rod. From the data, the intern created a shapefile of the perimeters of the *Phragmites australis* (Common Reed) patches and uploaded them to an existing geodatabase of the site.

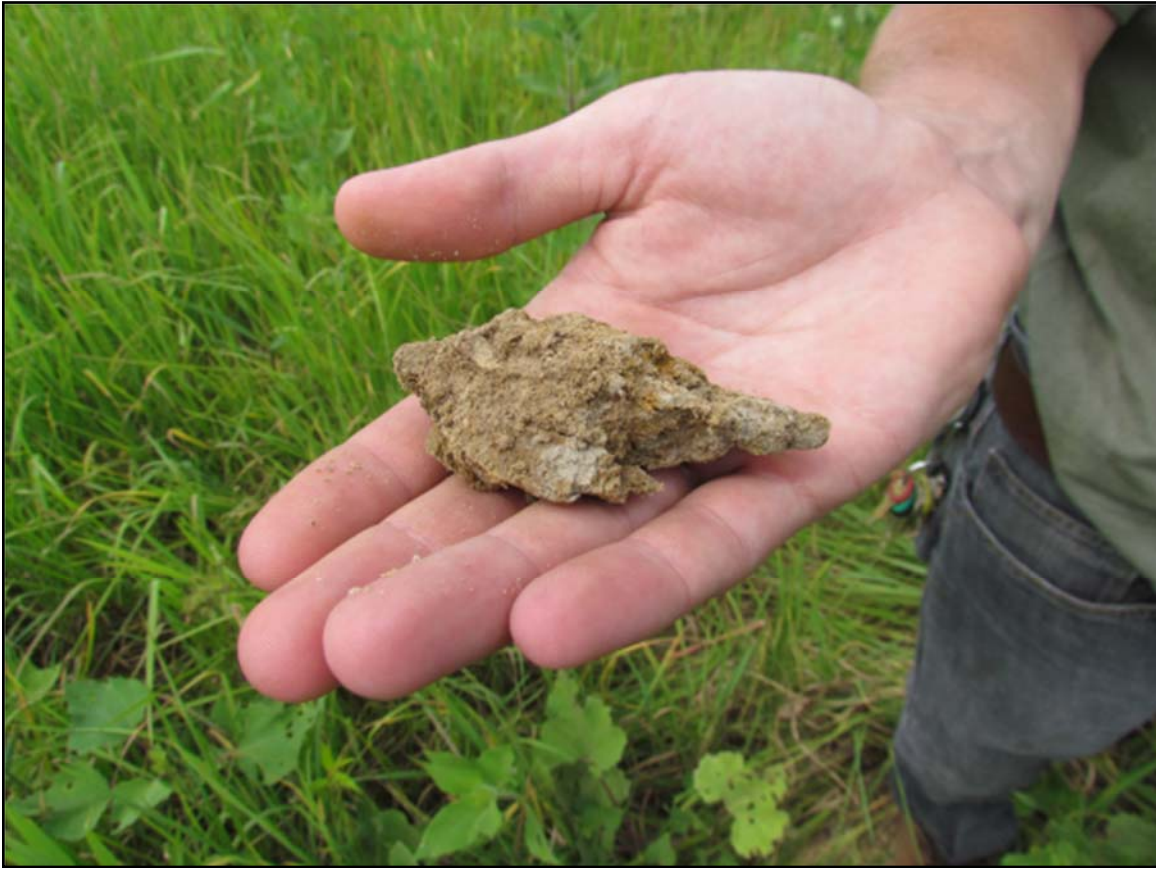
**Figure 7: A handful of soil is obtained at site HR W03 to test if hydric soil indicators are present. Iron redox concentrations (orange areas) can be seen.**

Hydric soils were present at site HR W03. Soil type 10YR 5/1 at 60% and 10 YR 5/6 at 40% was found. A sandy loam texture was determined and a sandy redox hydric soil indicator was found. There was a low chroma matrix with iron redox concentrations. Iron redox concentrations are typically rust colored, red or orange. They occur when iron

is reduced in anaerobic conditions and becomes soluble in soil solution. The iron in the solution oxidizes and re-precipitates when the solution encounters air.

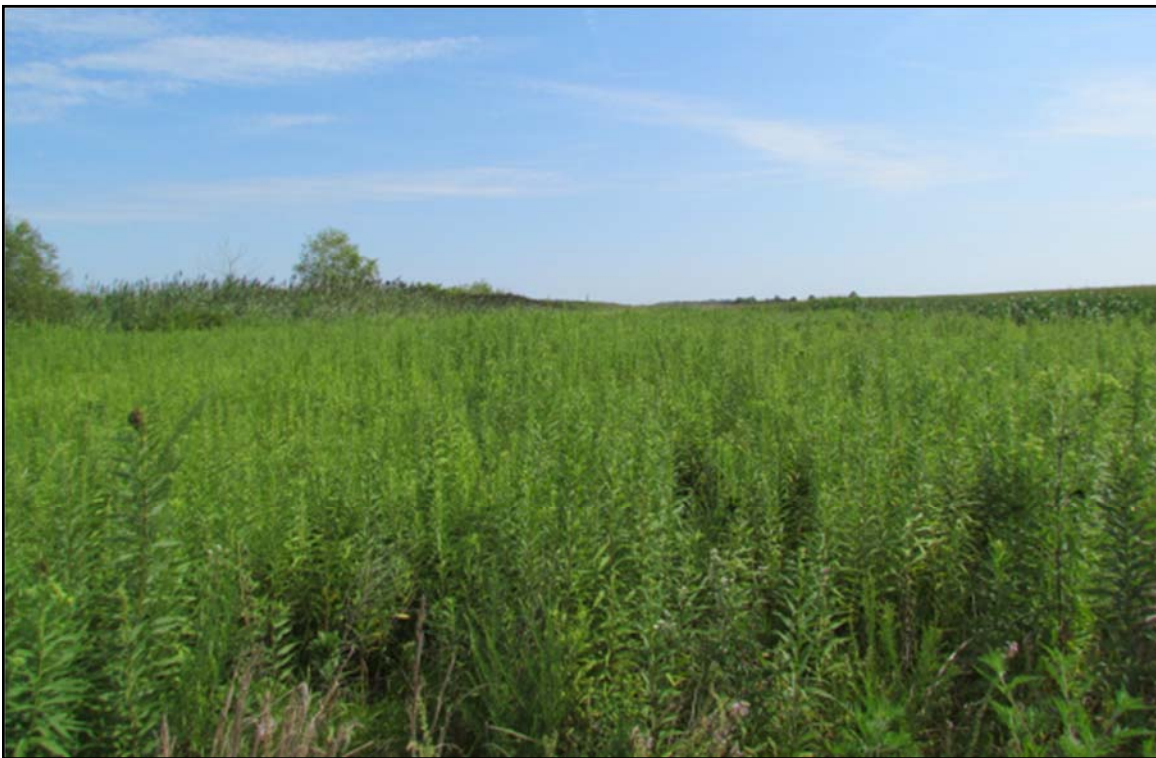
**Figure 8: A vegetative analysis is conducted at site HR W04 within Burning Star No. 4.**

FACW woody vegetation at the site consisted of *Liquidambar styraciflua* (America Sweet Gum) at 20% absolute cover and *Platanus occidentalis* (American Sycamore) at 10% absolute cover. A 10% absolute cover of *Quercus alba* (White Oak), with a FACU indicator status was found. The only dominant herb stratum found was *Spartina pectinata* (Tall Marshgrass), with a FACW indicator status and 60% absolute cover. Hydrophytic vegetative indicators 2 (dominance test) and 3 (prevalence index <3.0) were present.

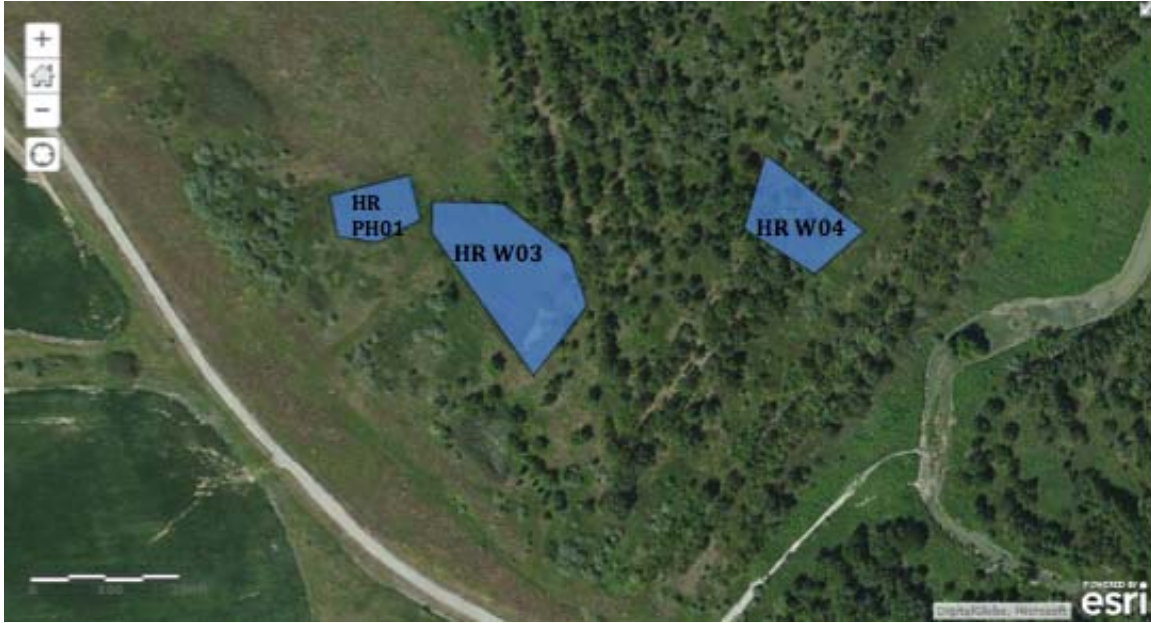
**Figure 9: Delineated wetlands HR PH01, HR W03, and HR W04 at Burning Star No. 4.**

It is my recommendation that the new haul road avoid areas HR PH01, HR W03, and HR W04. These areas demonstrate wetland characteristics as determined by the U.S. Army Corps of Engineers. Building a haul road over wetland areas will be more costly, and perhaps even require wetland mitigation. A professional engineer (PE) at MRR or Knight Hawk will develop the layout of the anticipated new haul road.

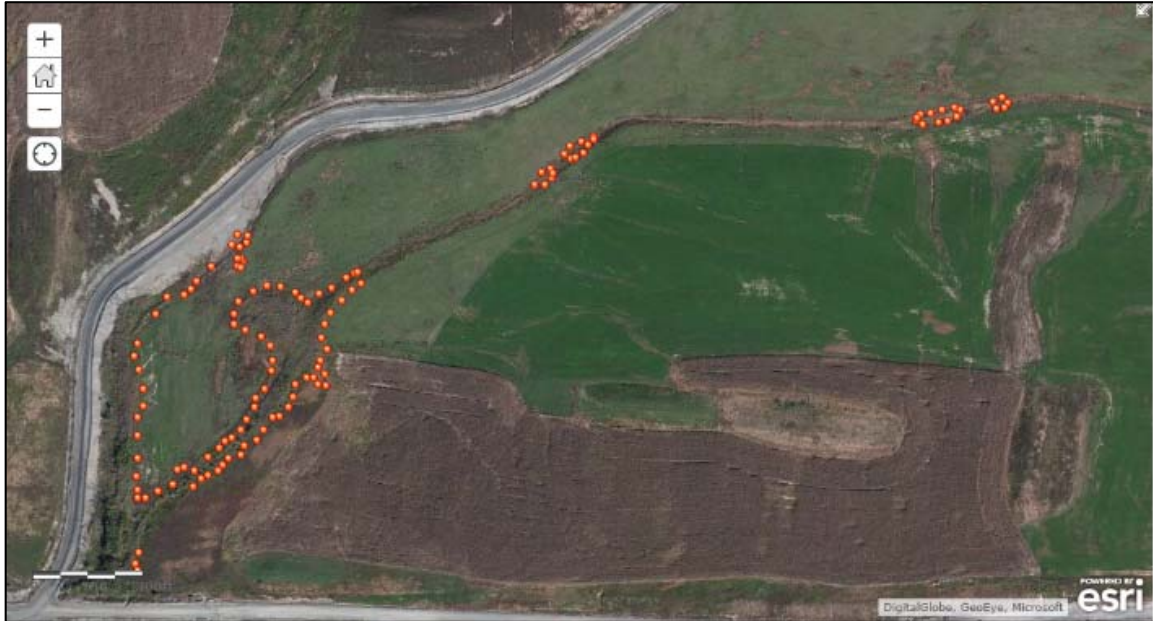
**Figure 11: A delineation of patches of *Phragmites australis* in the Walkers Creek site.**

A delineated map of *Phragmites australis* was created to help in managing future eradication efforts. Knight Hawk staff can use the map to locate the most extensive patches of *Phragmites australis* during control treatments. A calculation of the total area of *Phragmites australis* within Permit No. 314 can be determined from the digital map and utilized to predict the amount of control treatments necessary (e.g., amount of chemical spray needed). Lastly, the map can be used to model the spread or reduction of *Phragmites australis* patches over time.
